Geomatics' procedures and dynamic identification for the structural survey of the church of 'San Juan Bautista de Huaro' in Perú

R. Aguilar, M.F. Noel, C. Briceño, D. Arce & B. Castañeda
Pontificia Universidad Católica del Perú, Lima, Perú

ABSTRACT: This paper presents the feasibility of combining geometrical survey and in-situ non-destructive testing for the structural assessment of historical earthen constructions, which has typically difficult and non-documented geometries, unknown and highly variable materials, not visible damage states, and non-well defined boundaries and diaphragm conditions. Particularly, this paper presents the results of geometrical and structural surveys that are being carried out in the church 'San Juan Bautista de Huaro' in Cusco, Perú, as part of an ongoing research aiming at assessing its seismic vulnerability. The church dates back to the 17th Century and represents a typical Andean adobe church. Regarding to geometry, novel techniques such as laser scanning and photogrammetry from drones were successfully integrated to generate an accurate 3D reconstruction, and a numerical model of the building for seismic analysis. This numerical model was preli

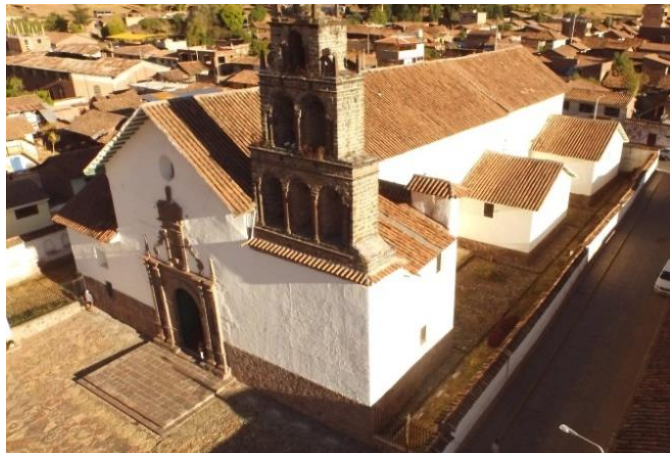
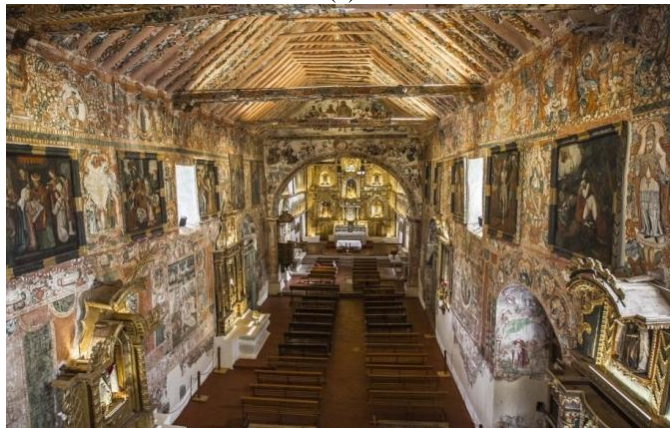
Figure 1. Church of ‘San Juan Bautista’ of Huaró: (a) exterior view; (b) interior view (Ruta Del Barroco Andino 2015).

As shown in Figure 1a, the church comprises an enlarged nave, a presbytery, a baptistery, a bell tower, a sacristy and an anti-sacristy, and two side chapels. The main nave is connected to the bell tower, choir loft, arcade, baptistery and the two lateral chapels. In the presbytery sector, there are located the triumphal arch, the sacristy and the anti-sacristy. Interior views are presented in Figure 1b.

The structural system is composed by adobe walls, with an average thickness and height of 1.6m and 11m, respectively. The foundations are of stone masonry walls and the roofing system is of an A

shape timber truss known as ‘par y nudillo’. The lateral walls are restrained by pairs of timber tie-beams, which are distributed along the nave. Additionally, the door frame and the bell tower are made of stone masonry.

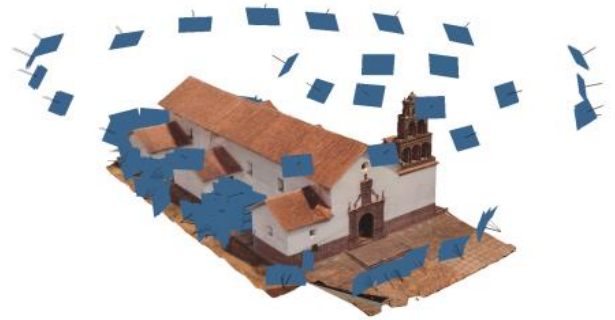
Figure 2. Image acquisition for photogrammetric 3D reconstruction of the church of ‘San Juan Bautista de Huaró’

The aerial photographs were taken using an UAV. A total of 24 aerial photographs from outside of the temple were taken, considering an average distance of 30 m between the camera and the sur-

face. Terrestrial photogrammetry was conducted using a digital camera Sony Nex 7 of 23 MP. Around 300 terrestrial photographs were taken focusing in the corners between nave and chapels, as well as on the back wall of the church. In Figure 2 shows the positions where terrestrial and aerial photographs were taken (blue rectangles). This figure also shows the flight route followed by the UAVs.

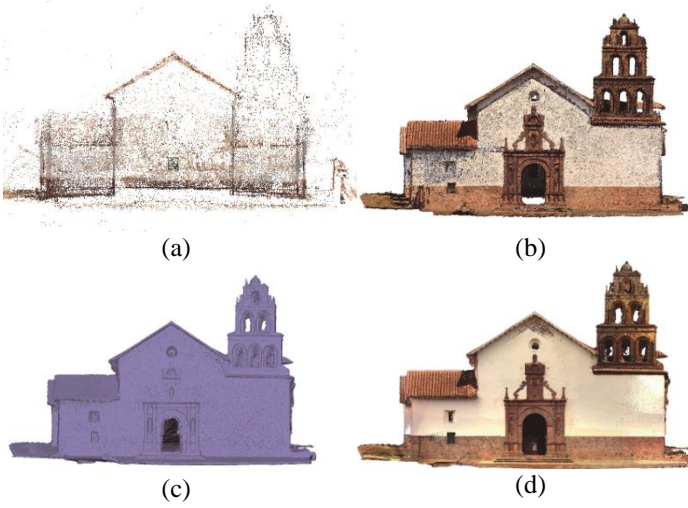
Figure 3. Photogrammetry process for model generation of the church of ‘San Juan Bautista’ of Huaru: (a) sparse cloud; (b) dense cloud; (c) triangular mesh; and (d) texturized model

The process for the geometrical 3D reconstruction was composed of four stages: 1) photograph alignment and generation of the sparse point cloud; 2) generation of the dense point cloud from the sparse cloud; 3) triangular mesh generation based on the dense cloud; and 4) textured model generation considering photographs. Due to the particularities of the building, the model was built through processing of individual segments, which were then integrated into a single model. The characteristics of each step are summarized in Table 1. Figure 3 shows the results obtained from each stage of the process.

Reconstruction stages	Characteristics	Figure
Sparse cloud	60,877 points	3a
Dense cloud	68,837,359 points	3b
Triangular mesh	4,783,138 vertex and 2,391,616 faces	3c
Texturized model	40,960 x 40,960 pixels	3d

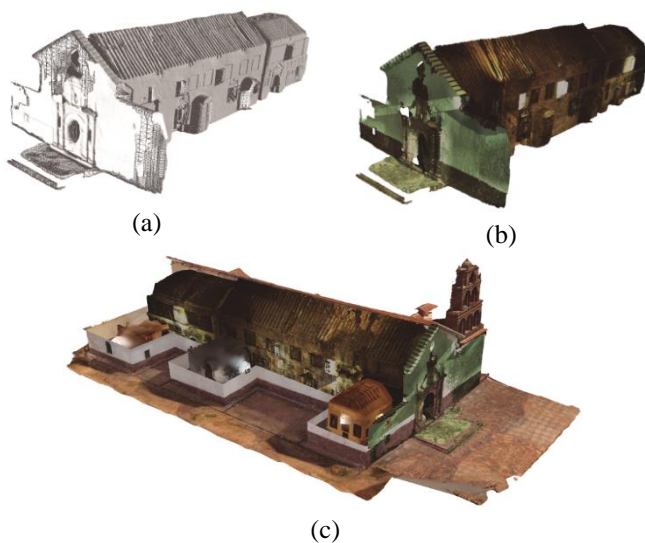
Figure 4. Model generation using laser scanner data of from the church of ‘San Juan Bautista’ of Huaru: (a) uncolored triangular mesh and (b) texturized model, (c) combined model using photogrammetry and TLS

For the reconstruction with TLS, the data of the scanning sessions was processed using the software Cyclone Leica® (Leica Geosystems, 2015). The resulting point cloud had a total of 23,683,162 points. The next step involved the manual cleanup of the undesired points acquired by the scanner. Later, the triangular mesh generation was conducted using the Poisson Surface Reconstruction algorithm (Ahmadabadian et al., 2013) implemented on the software MeshLab. The results obtained from this process are shown in Figures 4a and Figure 4b. In Figure 4c, the final model is presented, which was generated combining exterior and interior data obtained from photogrammetry and TLS, respectively.

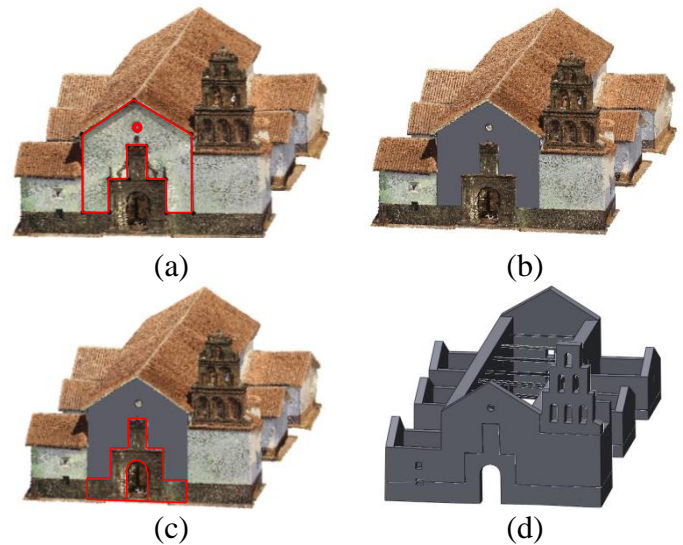
Figure 5. Modeling process of Huaru Church: first step (a) contour definition of frontal façade (b) extrusion of the façade contour (c) contour generation of stone doorway based on previous volumes; second step (d) final merged model

The construction of volumes needed the previous definition of boundaries of sections which was carried out by drawing lines, arcs and polylines using the point cloud as reference. Figures 5a and 5b show the defined contour of the facade and its extrusion volume, respectively. A perfect coincidence among generated volumes is necessary to omit the creation of problematic volumes, which would difficult the generation of the finite element mesh. Figure 5c shows the boundary generation of the stone doorway, considering as reference the contours of the adjacent volumes. Finally, all volumes that represented structural elements with same materials were merged. The final solid model, which is shown in Figure 5d, was composed of only four volumes: bell tower, church body, tie-beams as well as the foundation with the doorway.

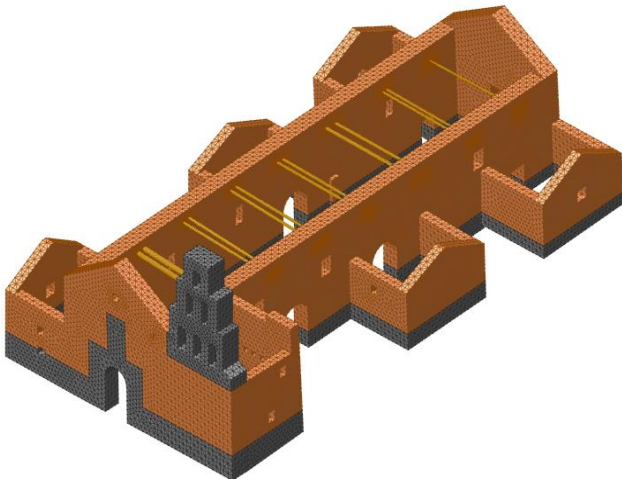
Figure 6. Finite element model of the church

The FE model of the church was subsequently built in DIANA TNO® (TNO DIANA, 2015). Adobe walls, wooden tie-beams, stone foundation and bell tower were modelled using tetrahedral elements. Due to section variations in the solid model, detailed mesh were required in certain areas (i.e., connections between beams and lateral walls). The roof was not modelled due to the complexity of simulating the rotational and sliding connections following the suggestions of Fonseca & D’ Ayala (2012). However, the weight of the roofing system was represented

by distributed masses located on top of the walls. In Figure 6, a general view of the developed FEM is presented.

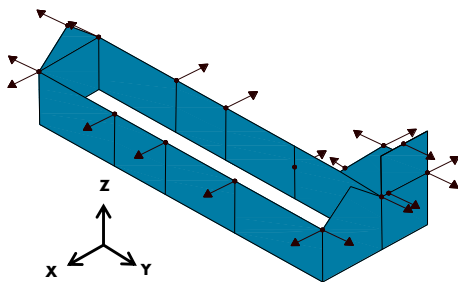
Figure 7. (a) Schematic view of the operational modal analysis test setup

The OMA tests consisted on the measurement of twenty degrees of freedom in the building, as shown in Figure 7a. The transducers were piezoelectric accelerometers with a sensitivity of 10V/g and a dynamic range of $\pm 0.5g$, as well as an acquisition system of 24-bit of resolution. The acquisition considered sampling rates and sampling times of 200 Hz and 10 minutes, respectively.

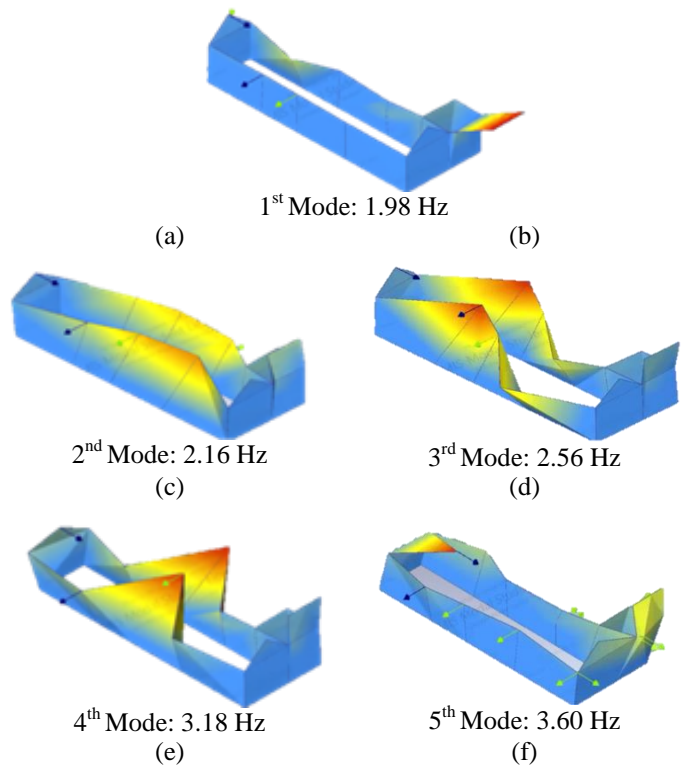
Figure 8. Modal identification tests in the church: (a) first, (b) second, (c) third, (d) fourth and (e) fifth modal shapes

The data processing carried out using the Stochastic Subspace Identification Technique (SSI) method implemented in ARTEMIS[®] (SVS, 2015) provided the possibility of identifying the first five modal shape of the building (Figure 8(a-f)). As shown, the movement of first mode is concentrated on the bell tower, while the following three modes are translational vibration of the nave. The fifth mode shows an out-of-plane movement on the timpani of the two façades and the bell tower.

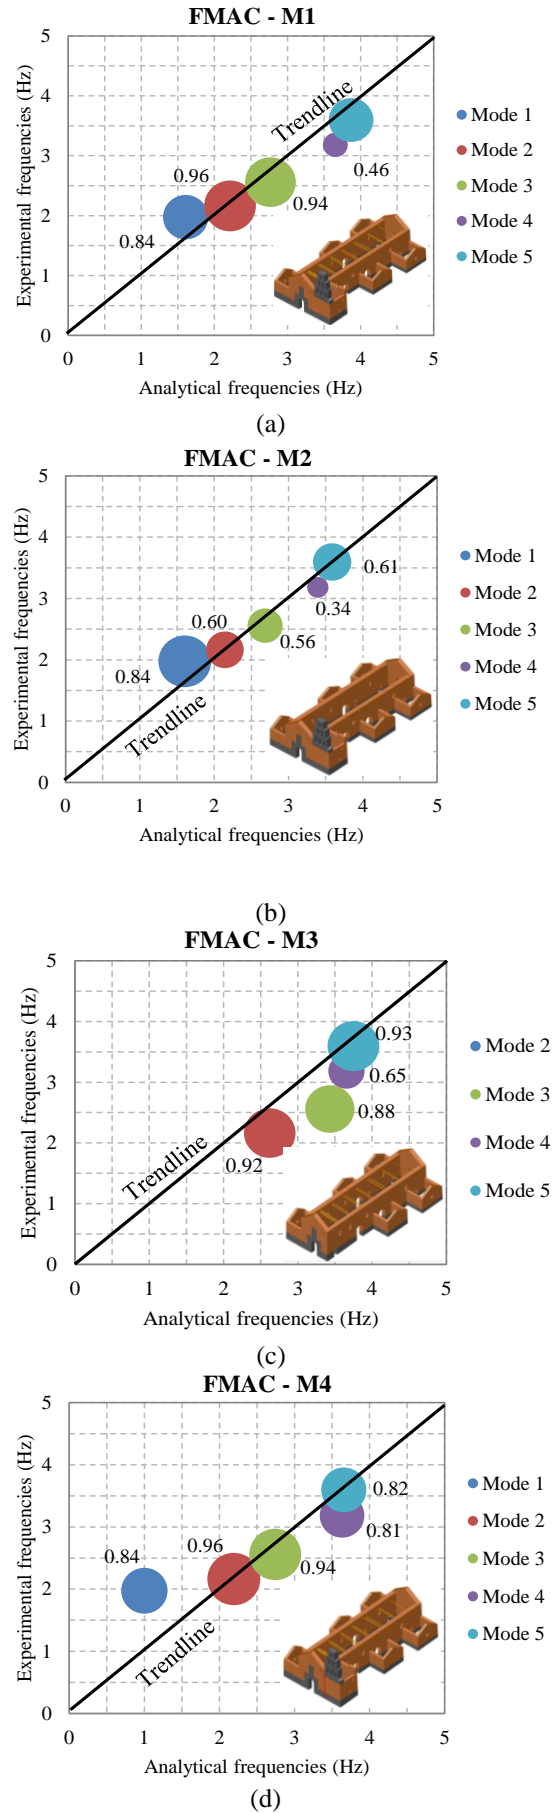
Figure 9. FMAC graphics corresponding to the church, when (a) wooden tie-beams were considered (Model M1); (b) without tie-beams (Model M2); (c) omitting belfry tower (Model M3) and (d) considering a transitional material (Model M4)

Figure 8 presents FMAC graphics for each model, comparing the results of the first five experimental and analytical modes. The results from the complete model with wooden tie beams (M1) evidenced a good correlation in terms of frequencies and MAC values for the first four vibration modes. In this case, the comparison in the fifth vibration mode did not show a good correlation. In the second model (M2), analytical results and experimental measurements showed low agreement, demonstrating the importance of considering the tie-beams timber to connect the two parallel walls of the nave. For third model (M3), results showed high MAC values and low frequency correspondence. However, the fifth mode showed an evident improvement in both indicators when compared to model M1. In addition, the first experimental modal shape was not detected since this mode corresponded to a local vibration of the bell tower. The model M4 showed an improvement of MAC values for the fourth and fifth modes but a reduction in the frequency ratio of the first mode in comparison to the initial model M1.

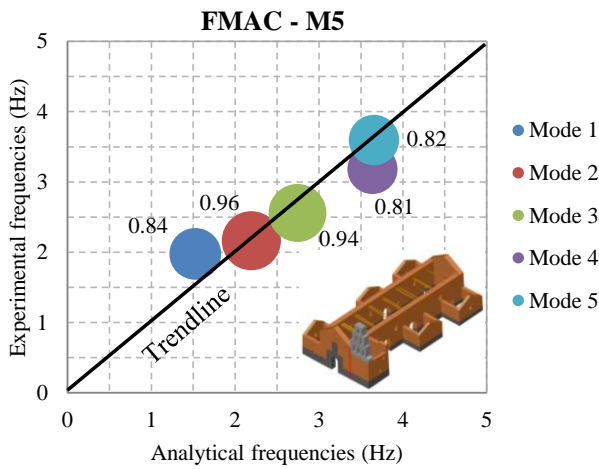
Figure 10. FMAC graphic corresponding to M5

The previous numerical and experimental results evidenced that the first vibration mode is a local mode of the bell tower which is composed by a single material (stone masonry). Aiming at improving results of M4 model, a new value for the elasticity modulus of stone masonry belonging to bell tower was set to 1000 MPa. This consideration was included in an additional numerical model (M5). The resultant FMAC graphic of this last model is presented in Figure 10. As shown, improved results were obtained since the difference between the value of the first analytical and experimental frequency has been drastically reduced. This modification did not affect modal shapes and consequently MAC values in all the five identified frequencies.

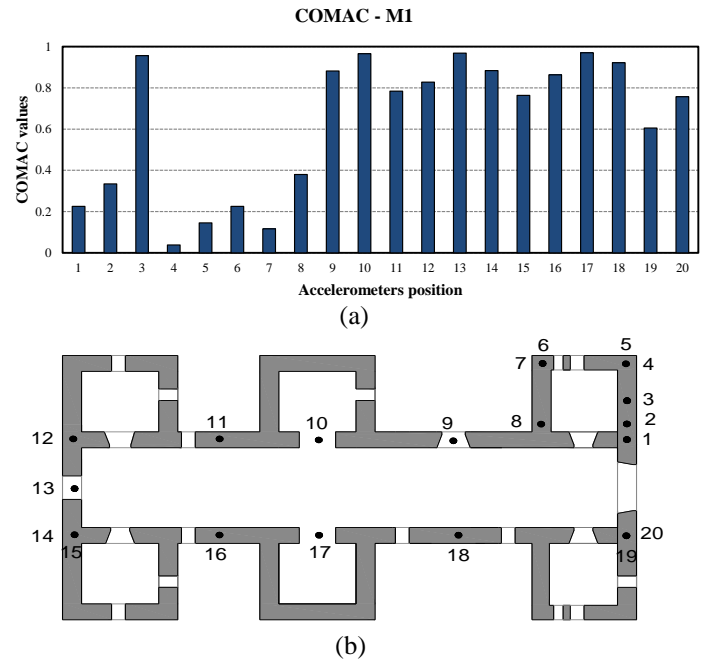
Figure 11. COMAC values for the 20 measuring points (a) COMAC graphic corresponding to M5 (b) scheme of arrangement of the accelerometers.

The final verification of the accuracy of model M5 considered the use of the Coordinate Modal Assurance Criterion (COMAC) which allowed obtaining local information from measurement points and identify which points causes a low correlations between experimental and analytical modal shapes. In Figure 10a, COMAC values for the twenty degrees-of-freedom are plotted, whose positions are shown in the schematic plan of Figure 10b. The results showed low MAC values in the first eight measurement positions, which belongs to the bell tower. Results indicate that still a further and more detailed calibration is required to have a better match between experimental and numerical results.
